LEAD IN DRINKING WATER TESTING REPORT

Empowerment Academy Charter School 211 Sherman Avenue Jersey City, New Jersey 07307

McCabe Environmental Services, L.L.C. 464 Valley Brook Avenue Lyndhurst, New Jersey 07071

MES Project No.: 22-04454

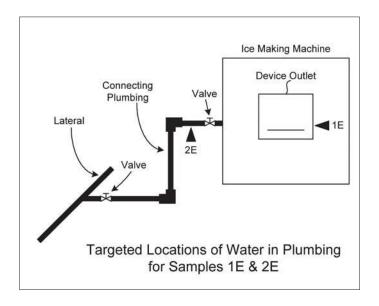
Disconnect the ice machine from the plumbing and look for a screen at the inlet. Remove the screen. If debris is present, forward a sample of the debris to the laboratory for analysis and clean out the remaining debris. The laboratory will determine whether lead solder is present. Clean the screen routinely to avoid accumulations of debris.

Collect the sample from the disconnected plumbing as close to the ice machine as possible. Fill the sample container with 250 mL of water. If no outlet is available, contact the ice machine manufacturer for recommendations that will minimize disruption of existing plumbing. Adding outlets or valves could add new sources of lead to the plumbing, even if the new devices are lead-free and meet NSF Standard 61, section 8. If a sample outlet or valve is available, collect the sample immediately after opening the outlet or valve.
