## LEAD IN DRINKING WATER TESTING REPORT

Empowerment Academy Charter School  
240 Ege Ave  
Jersey City, New Jersey 07304

**REPORT DATE:** December 29, 2022

**MES PROJECT NO.:** 22-04453

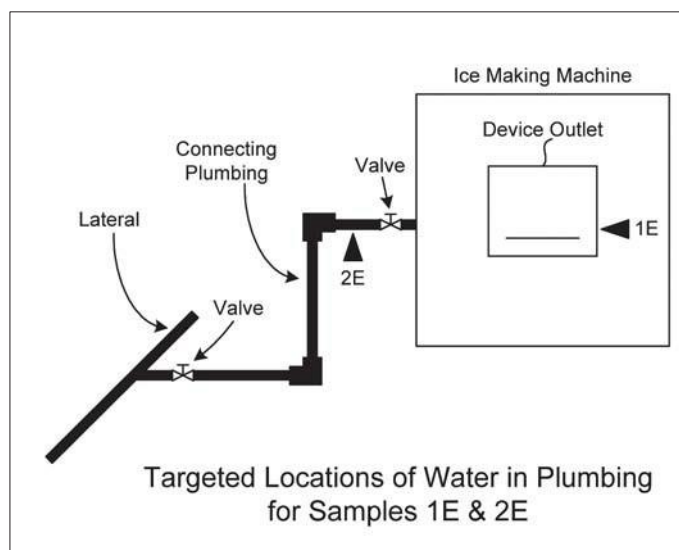
Disconnect the ice machine from the plumbing and look for a screen at the inlet. Remove the screen. If debris is present, forward a sample of the debris to the laboratory for analysis and clean out the remaining debris. The laboratory will determine whether lead solder is present. Clean the screen routinely to avoid accumulations of debris.

Collect the sample from the disconnected plumbing as close to the ice machine as possible. Fill the sample container with 250 mL of water. If no outlet is available, contact the ice machine manufacturer for recommendations that will minimize disruption of existing plumbing. Adding outlets or valves could add new sources of lead to the plumbing, even if the new devices are lead-free and meet NSF Standard 61, section 8. If a sample outlet or valve is available, collect the sample immediately after opening the outlet or valve.
